# Service Reports

January 2022

## Where are the service ports located? (And why does it matter?)

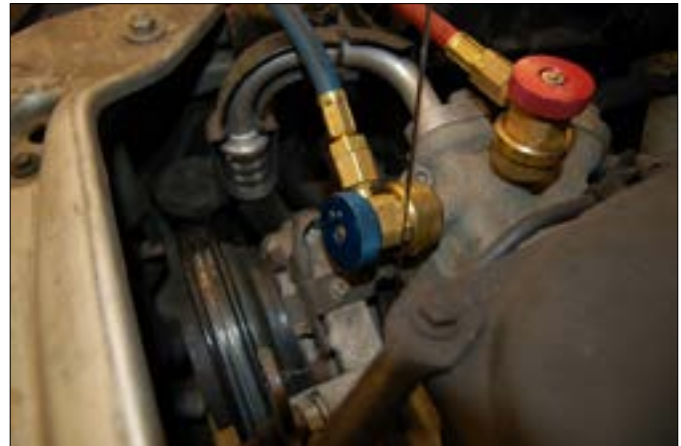
**Figure 1:** Having the service ports located right at the compressor, such as on this manifold, ensures being able to get the actual pressures the compressor is producing (unless there is a problem with a Schrader valve, hose connector, gauge or hose connected to the gauge).

Near the beginning of the webinar, I was asked the following question: If you were an A/C engineer at one of the OEMs and you had unlimited resources (and of course unlimited funds to do this), where is the ideal location to install service ports on an A/C system, and is there ever a reason to have more than one (of each)? To address the first part of the question: My preference is as close to the compressor as possible. See Figure 1. That's because I want to know for SURE what the compressor head pressure is and also want to know for SURE the level the compressor is pulling the low side down to, and taking readings right at the compressor is the only way you can be sure.

**NOTE:** Even with being connected to service ports right at the compressor, there is always the possibility of a problem with a Schrader valve, hose connector, gauge or hose connected to the gauge. So, for that reason, always make sure that gauge movement corresponds to temperature changes of metal lines right at the compressor.

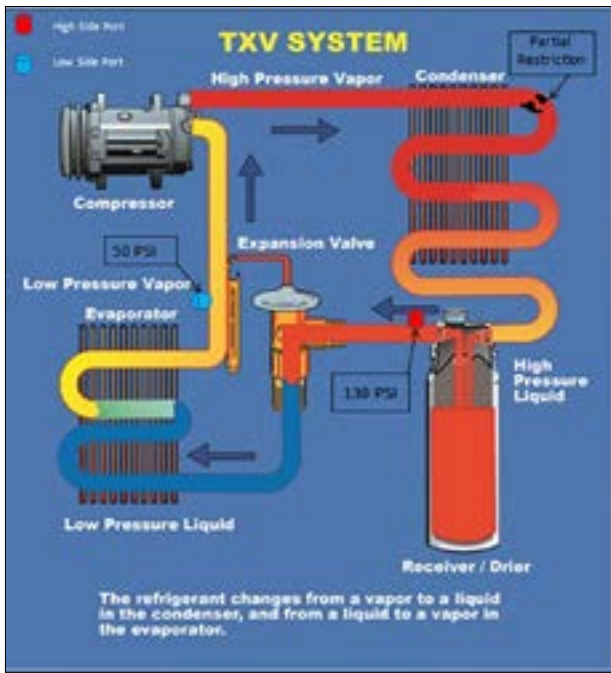
**Figure 5:** Expansion Valve System with a restricted condenser.

The next step is to create a partial restriction in the upper portion of the condenser. This affects condenser efficiency dramatically and the combination of the reduced condenser efficiency and the compressor pumping against the restriction is going to cause the pressure at the compressor to increase significantly and the low side pressure will also increase as a result. However, the pressure at the original service port location is going to drop significantly because that service port is located downstream of where the restriction is. With the high side

pressure showing up as 130 and the low side at 50, someone could easily diagnose that as a weak compressor. See Figure 5.

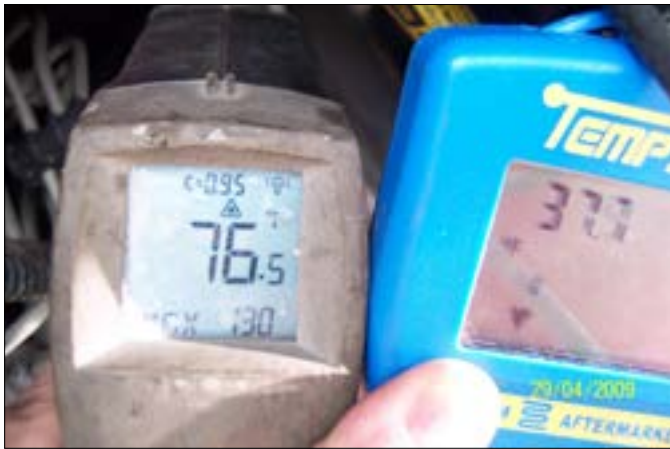
**Figure 7:** This is a typical reading that can be expected when taking temperature readings on an A/C system with an infrared temperature gun. Both the infrared gun on the left and the contact type temperature reading tool on the right are reading the temperature on the same metal suction line about 1/2-inch apart. Before doing the test, I felt the suction line with my hand, and it felt like a glass of iced tea. The reading on the contact type temperature reading tool indicates a temperature that would be expected of a glass of iced tea. However, the infrared gun indicates a temperature that is almost 40° higher. This was despite numerous efforts to get an accurate reading with it and was the lowest temperature recorded.

drier, there should be almost no difference in the inlet and outlet temperatures on those components. *CAUTION: You must use a contact type temperature reading tool to get accurate readings. Infrared temperature guns will result in inaccurate readings and an incorrect diagnosis. Infrared guns have their place in the shop when it comes to taking high temperature readings such as on an exhaust manifold when trying to find a misfiring cylinder but are just too inaccurate to use on lower temperature components such as those in an A/C system (Figure 7).*

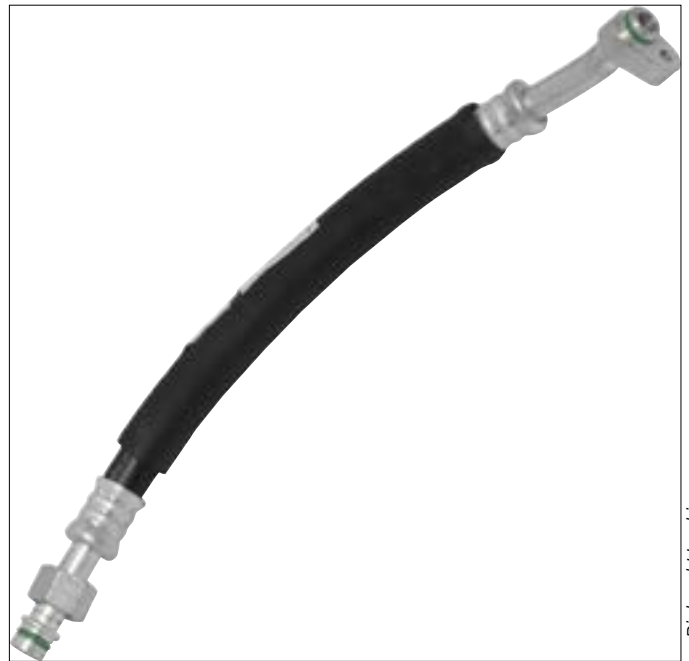
**Figure 8:** Honda suction hose. The straight metal tubing on one end and almost straight metal tubing on the other end made it easy to see daylight when looking through it, but it didn't look perfectly round on the inside.

went on to say that when he temperature tested it, there was a difference of about 50° from one end to the other. He thanked me and said he had never been so glad to get a car out of the shop. I asked what he'd done with the hose, and he said he'd thrown it in the trash can. I asked if I could possibly have the hose and he said he'd dig it out of the trash and set it aside for me. I went by and picked it up a couple of days later and I've taken it with me to just about every A/C clinic I've conducted since that time, and it's been used extensively to illustrate the effects that a restriction can have on pressure readings. See Figure 8.

Upon seeing the hose, the first thing I did was hold it up to the light and look through it. As you can see in the picture, it is only about 15 inches long and has straight metal tubing on one end and only a slight bend on the other end so it's very easy to look completely through it. The customer had indicated earlier that he had blown air through it and detected no restriction, and it was easy to see why. Looking through it, plenty of daylight could be seen at the other end. However, upon closer examination, something just didn't look right. Instead of being perfectly round all the way through on the inside, it had more of an elliptical shape to it toward the middle. To investigate further, the next step was to cut the hose apart. Once cut apart, it was easy to see what had happened. It is a barrier type hose and the inner liner had come loose as indicated in the picture. See Figure 9.

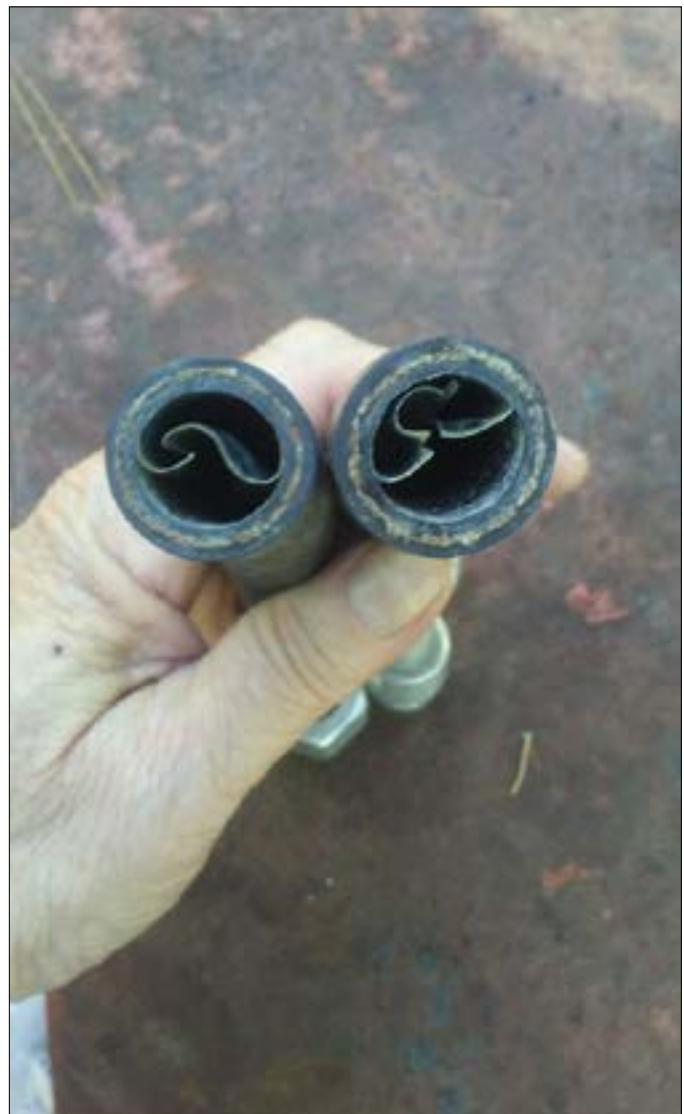
**Figure 9:** Cutting the hose in two at about the midway point revealed exactly what the problem was. The inner liner had come loose from the adjacent layer it had been attached to.

So, what was actually going on here? There were several inches of the internal liner that had come loose from

the layer that it attached to. With no refrigerant in it, there was no resistance encountered when trying to blow air or flush through. But with the system charged up and the compressor not running, the hose would have about 104 psi of static pressure inside (at 90°F). With the inner liner coming loose, there was also some damage that was allowing refrigerant to permeate through it and get to the area between the inner liner and the adjacent layer it was formerly attached to. When the compressor was turned on, it immediately started reducing the low side pressure. The higher pressure on the outer part of the inner liner caused the inner liner to collapse and caused a restriction. Based on the pressure readings of 135 to 140 on the high side and 60 to 65 on the low side, it wasn't a total restriction, but rather was a partial restriction (Figure 10). But the 60 to 65 on the low side gauge wasn't what the actual low side pressure was at the compressor. That's because the low side service port was located between the evaporator and where the collapsed area of the hose was located. It involves a bit of speculation, but if it had been possible to take a low side pressure reading there at the compressor it would have likely been in the low single digits or maybe
