Service Reports

By Richard Hawkins, MACS Technical Correspondent

January 2022

Where are the service ports located? (And why does it matter?)

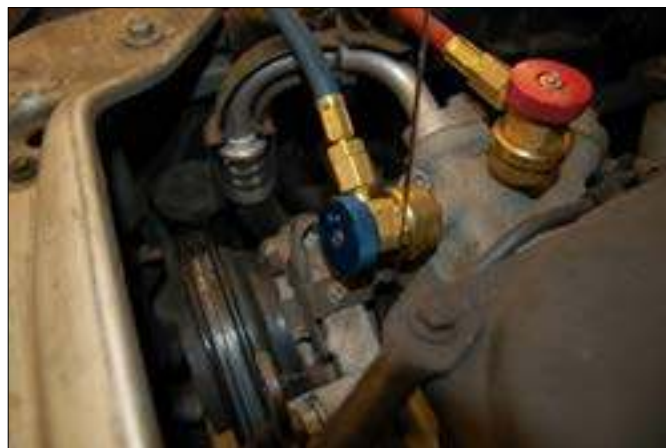
Figure 1: Having the service ports located right at the compressor, such as on this manifold, ensures being able to get the actual pressures the compressor is producing (unless there is a problem with a Schrader valve, hose connector, gauge or hose connected to the gauge).

Near the beginning of the webinar, I was asked the following question: If you were an A/C engineer at one of the OEMs and you had unlimited resources (and of course unlimited funds to do this), where is the ideal location to install service ports on an A/C system, and is there ever a reason to have more than one (of each)? To address the first part of the question: My preference is as close to the compressor as possible. See Figure 1. That's because I want to know for SURE what the compressor head pressure is and also want to know for SURE the level the compressor is pulling the low side down to, and taking readings right at the compressor is the only way you can be sure.

NOTE: Even with being connected to service ports right at the compressor, there is always the possibility of a problem with a Schrader valve, hose connector, gauge or hose connected to the gauge. So, for that reason, always make sure that gauge movement corresponds to temperature changes of metal lines right at the compressor.

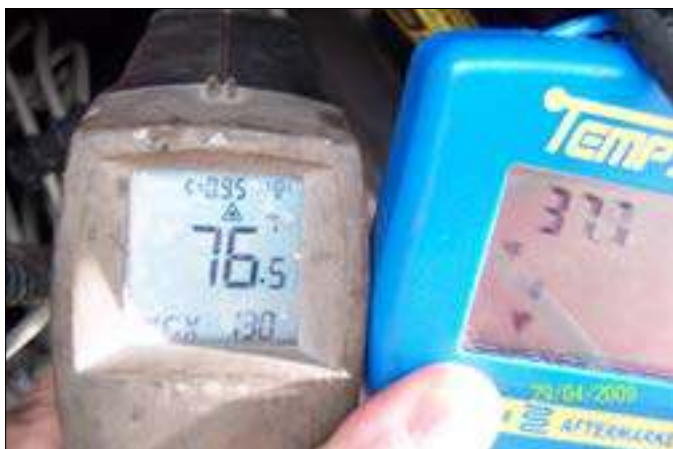
Figure 7: This is a typical reading that can be expected when taking temperature readings on an A/C system with an infrared temperature gun. Both the infrared gun on the left and the contact type temperature reading tool on the right are reading the temperature on the same metal suction line about 1/2-inch apart. Before doing the test, I felt the suction line with my hand, and it felt like a glass of iced tea. The reading on the contact type temperature reading tool indicates a temperature that would be expected of a glass of iced tea. However, the infrared gun indicates a temperature that is almost 40° higher. This was despite numerous efforts to get an accurate reading with it and was the lowest temperature recorded.

drier, there should be almost no difference in the inlet and outlet temperatures on those components. *CAUTION: You must use a contact type temperature reading tool to get accurate readings. Infrared temperature guns will result in inaccurate readings and an incorrect diagnosis. Infrared guns have their place in the shop when it comes to taking high temperature readings such as on an exhaust manifold when trying to find a misfiring cylinder but are just too inaccurate to use on lower temperature components such as those in an A/C system (Figure 7).*

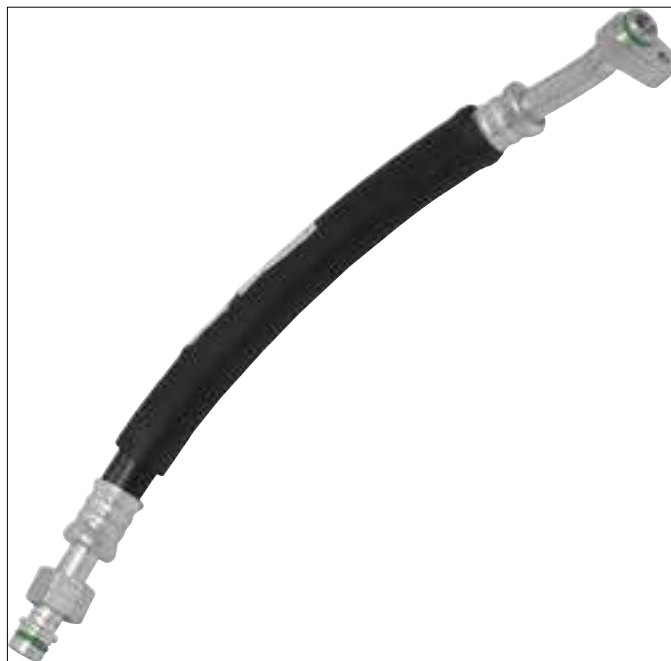
Figure 8: Honda suction hose. The straight metal tubing on one end and almost straight metal tubing on the other end made it easy to see daylight when looking through it, but it didn't look perfectly round on the inside.

went on to say that when he temperature tested it, there was a difference of about 50° from one end to the other. He thanked me and said he had never been so glad to get a car out of the shop. I asked what he'd done with the hose, and he said he'd thrown it in the trash can. I asked if I could possibly have the hose and he said he'd dig it out of the trash and set it aside for me. I went by and picked it up a couple of days later and I've taken it with me to just about every A/C clinic I've conducted since that time, and it's been used extensively to illustrate the effects that a restriction can have on pressure readings. See Figure 8.

Upon seeing the hose, the first thing I did was hold it up to the light and look through it. As you can see in the picture, it is only about 15 inches long and has straight metal tubing on one end and only a slight bend on the other end so it's very easy to look completely through it. The customer had indicated earlier that he had blown air through it and detected no restriction, and it was easy to see why. Looking through it, plenty of daylight could be seen at the other end. However, upon closer examination, something just didn't look right. Instead of being perfectly round all the way through on the inside, it had more of an elliptical shape to it toward the middle. To investigate further, the next step was to cut the hose apart. Once cut apart, it was easy to see what had happened. It is a barrier type hose and the inner liner had come loose as indicated in the picture. See Figure 9.

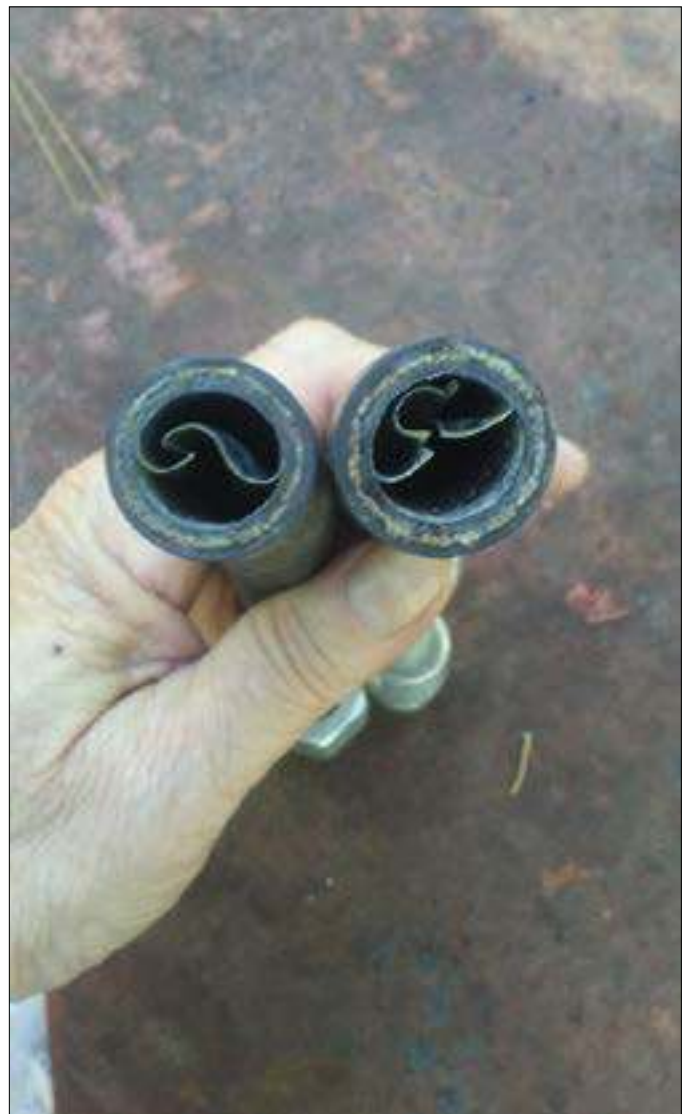
Figure 9: Cutting the hose in two at about the midway point revealed exactly what the problem was. The inner liner had come loose from the adjacent layer it had been attached to.

So, what was actually going on here? There were several inches of the internal liner that had come loose from

the layer that it attached to. With no refrigerant in it, there was no resistance encountered when trying to blow air or flush through. But with the system charged up and the compressor not running, the hose would have about 104 psi of static pressure inside (at 90°F). With the inner liner coming loose, there was also some damage that was allowing refrigerant to permeate through it and get to the area between the inner liner and the adjacent layer it was formerly attached to. When the compressor was turned on, it immediately started reducing the low side pressure. The higher pressure on the outer part of the inner liner caused the inner liner to collapse and caused a restriction. Based on the pressure readings of 135 to 140 on the high side and 60 to 65 on the low side, it wasn't a total restriction, but rather was a partial restriction (Figure 10). But the 60 to 65 on the low side gauge wasn't what the actual low side pressure was at the compressor. That's because the low side service port was located between the evaporator and where the collapsed area of the hose was located. It involves a bit of speculation, but if it had been possible to take a low side pressure reading there at the compressor it would have likely been in the low single digits or maybe
